**US Army Corps
of Engineers**

Technical Report HL-94-1
May 1995

Demonstration Erosion Control Project Monitoring Program

Fiscal Year 1993 Report

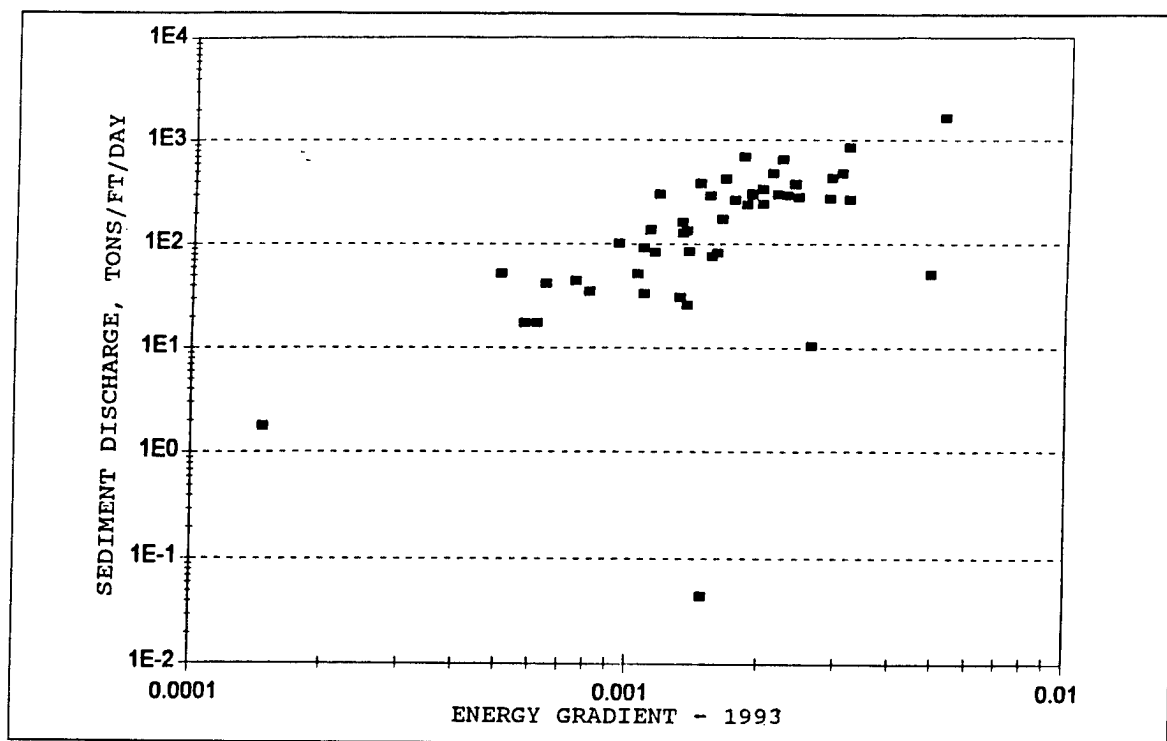
Figure 109 illustrates the relationship between the energy gradient and sediment discharge computed for each of the monitoring segments using the smaller of the bank-full or 2-year discharge. Sediment discharge increases with increasing gradient. Some of the scatter can also be attributed to the size of the sediment available for transport. For example, the three points that are generally lower and to the right of most of the data are for segments for which the bed sediment of $D_{50} = 10$ mm was used. The remaining points are computed using sediment in the sand ranges.

Figure 109. Unit sediment discharge for the smaller of the bank-full or 2-year discharge plotted as a function of energy gradient for Hotophia Creek

The previous discussion of Hotophia Creek indicated that sediment yield could be reduced to approximately 5.2 tons/acre/year. For Hotophia Creek this converted to approximately 30 tons/ft/day at the bank-full discharge. As shown in Figure 109, 30 tons/ft/day would represent a significant, attainable improvement for most of the monitoring segments. Only 2-year discharges are available for most of the segments; therefore, an example that achieves 30 tons/ft/day sediment discharge for segment 1 of Red Banks Creek is presented in Figures 110 and 111. Figure 110 is the comparison of the 1992 and

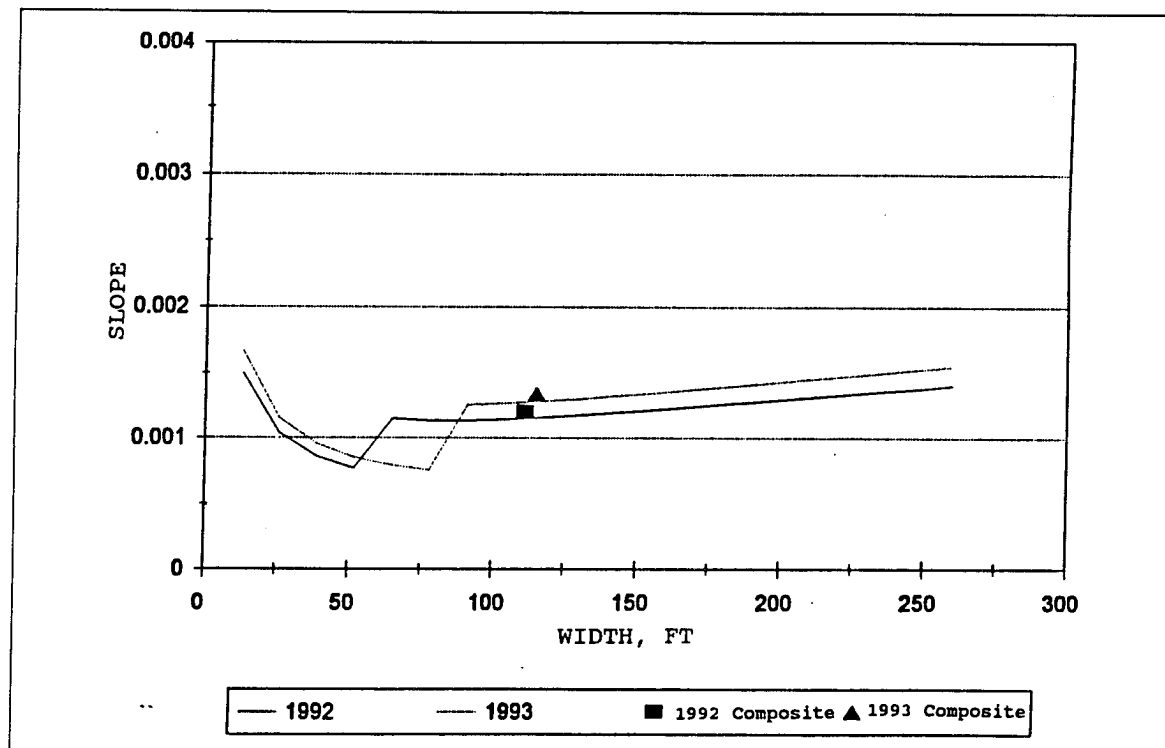
Figure 110. Comparison of stable channel computation and composite cross-section data for existing condition sediment yield of 124 tons/ft/day for 1992 and 137 tons/ft/day for 1993, Red Banks Creek, segment 1

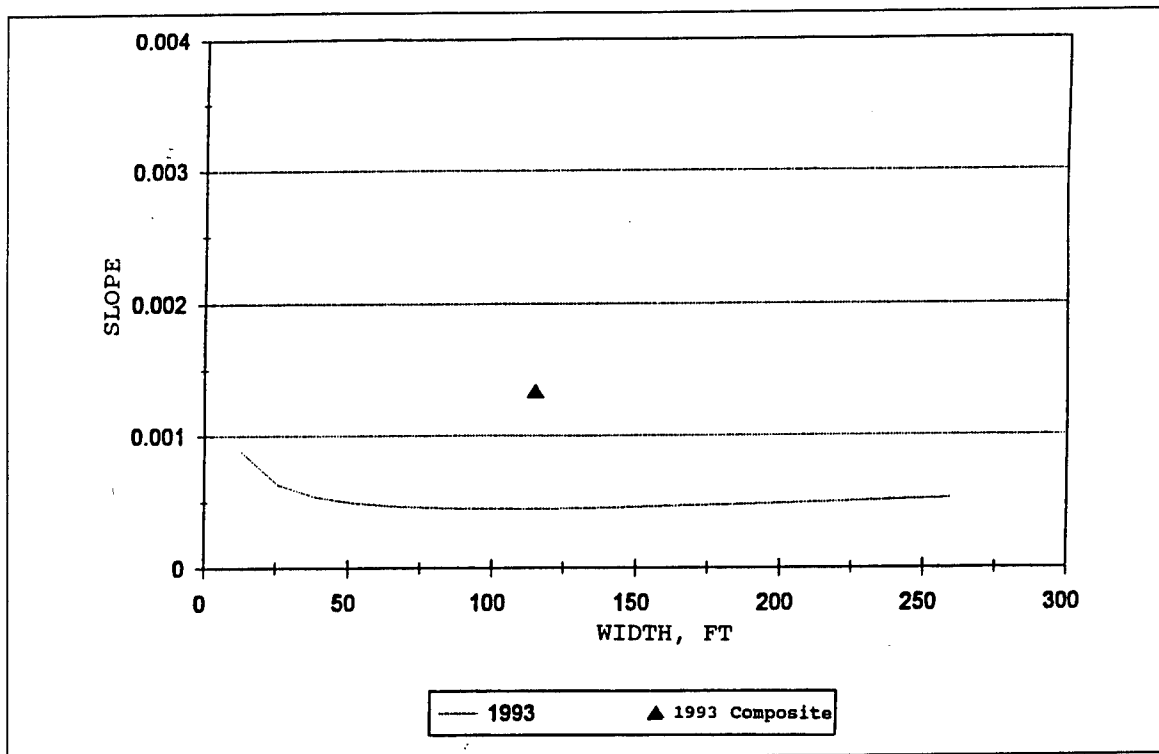
Figure 111. Comparison of composite cross-section data for 1993 with a stable channel computation for a hypothetical sediment yield of 30 tons/ft/day, Red Banks Creek, segment 1 (adjusted)

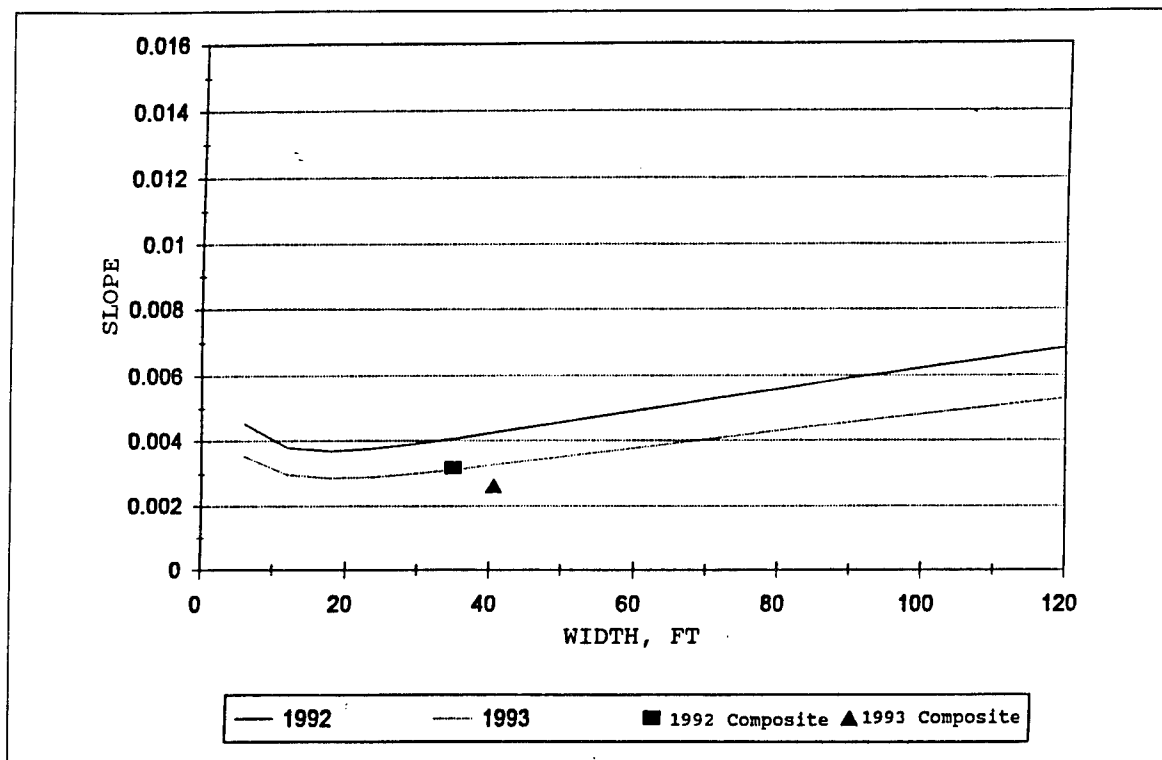
Figure 112. Comparison of 1992 and 1993 stable channel computation with composite cross-section data for the observed bed sediment, $D_{50} = 10$ mm, Nolehoe Creek, segment 1

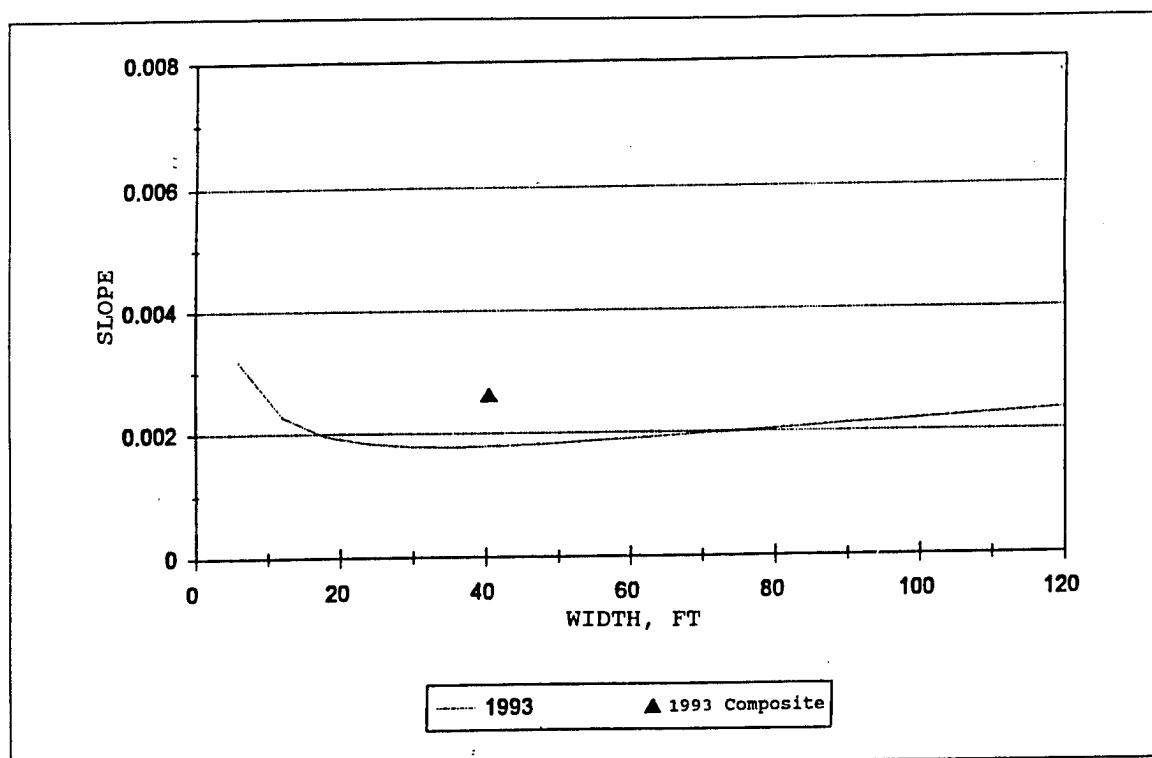
Figure 113. Comparison with the 1993 composite cross-section data with the stable channel computation for bed sediment of $D_{50} = 0.50$ mm, Nolehoe Creek (using sediment characterized from Harland Creek)

comparison of 1992 and 1993 stable channel computations with composite cross-section data for the observed bed sediment, which was found to be scattered, thin deposits of gravel ($D_{50} = 10$ mm) over an erosion-resistant clay. Figure 112 indicates that the segment is aggradational. Figure 113 is a comparison of the 1993 composite section data and a stable channel computation for Nolehoe Creek using a mixed sand and gravel bed sediment measured in Harland Creek ($D_{50} = 0.50$ mm). Using the smaller sediment size, the stable channel slopes reduce significantly. In the situation for Nolehoe Creek, sediment should be obtained from upstream and downstream sites that the designer judges to be representative of the bed sediment that will result as the segment becomes stable.

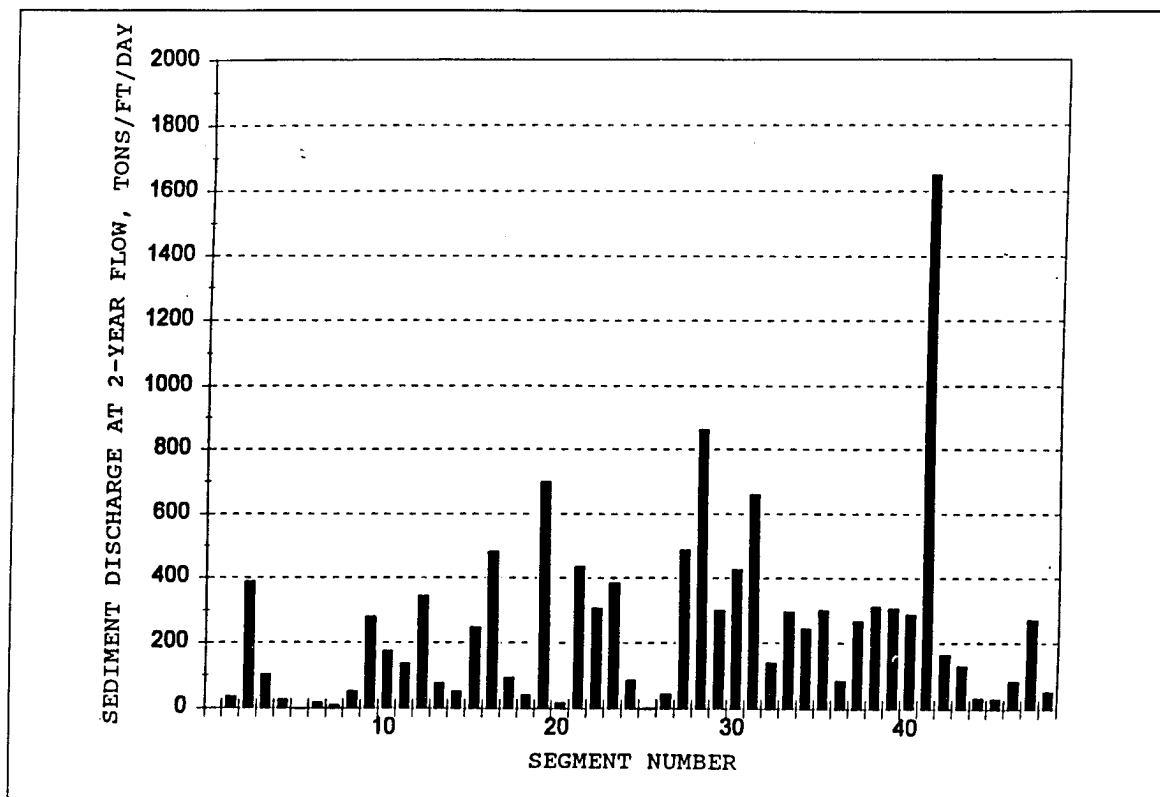
Figure 114 is a bar chart depicting the 1993 sediment discharge for each segment. Sediment concentration for 1993 was reduced by approximately 15 percent from 1992 levels based on the average of all segments included in both the 1992 and 1993 data set.

The top ten sediment discharge rate segments are above 20,000 tons/day and are as follows (given by site and segment number): West Worsham 18W-4; Lower Hotophia 13-1; Perry 16-4; Red Banks 9-1; East Worsham 18E-2; Fannegusha 2-1; Otoucalofa 14-1; Sykes 17-1; Perry 16-3; and East Worsham 18E-1. Perry Creek sites should be ignored because construction was underway during the 1993 survey. The sites on Otoucalofa, Sykes, Fannegusha, and East Worsham have no structural downstream control. Of the top ten, the remaining sites are Red Banks Creek with chevron weirs, and Lower Hotophia and West Worsham Creeks, with low-drop structures. The apparent stability of the chevron weirs on Red Banks may be due in part to the high sediment supply to the reach. A previous recommendation was made for analyses of the reach. Lower Hotophia Creek may become a critical situation because three high-drop structures are now in place upstream of the reach. The reduction in sediment supply caused by these structures may cause scour of the reach, and careful monitoring of the reach is vital. Consideration for additional stabilization measures is recommended for the portion upstream of grade control on West Worsham.

Figure 114. Segment sediment discharge

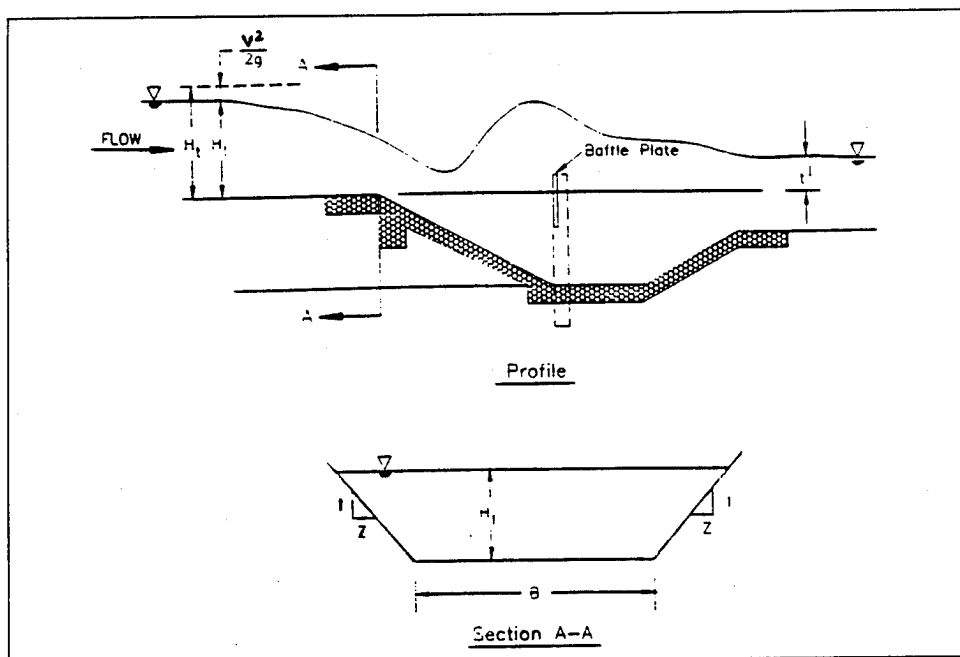
Figure 115. Definition sketch

V = upstream average flow velocity, ft/sec

g = acceleration of gravity, ft/sec²

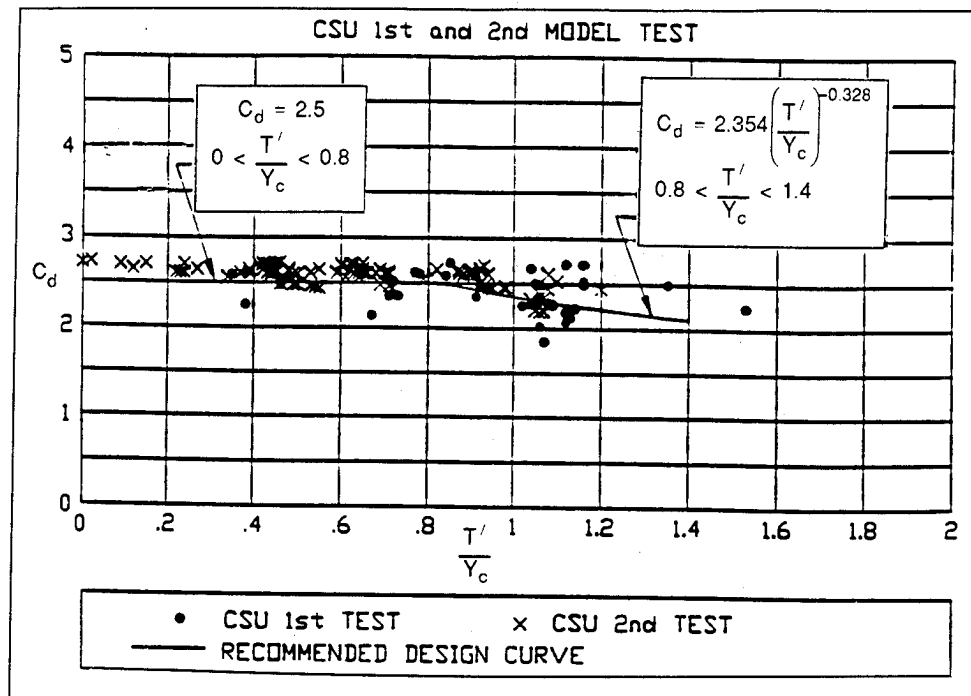
Figure 116 shows the relationship between the discharge coefficient and submergence for the CSU data. Linear regression curve fitting techniques were applied to the data with the following results:

$$C_d = 2.354 \left[\frac{t'}{Y_c} \right]^{-0.328} \quad 0.8 < \frac{t'}{Y_c} < 1.4 \quad (3)$$

Figure 116. Discharge coefficients model data

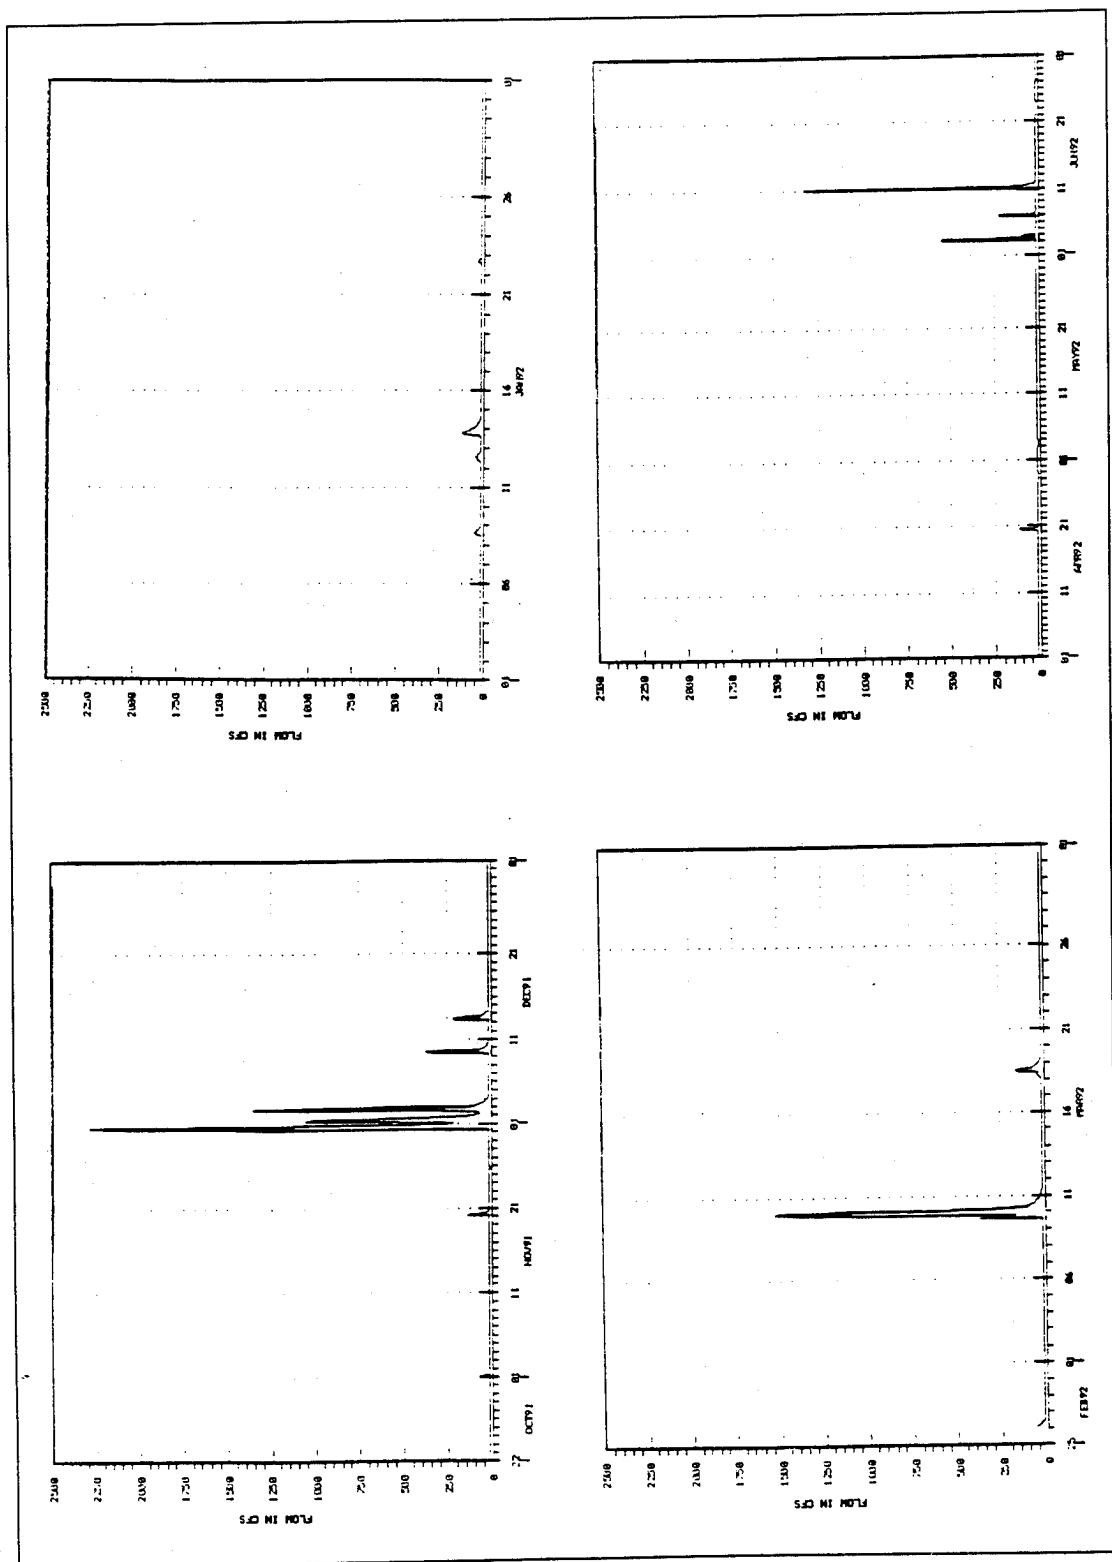
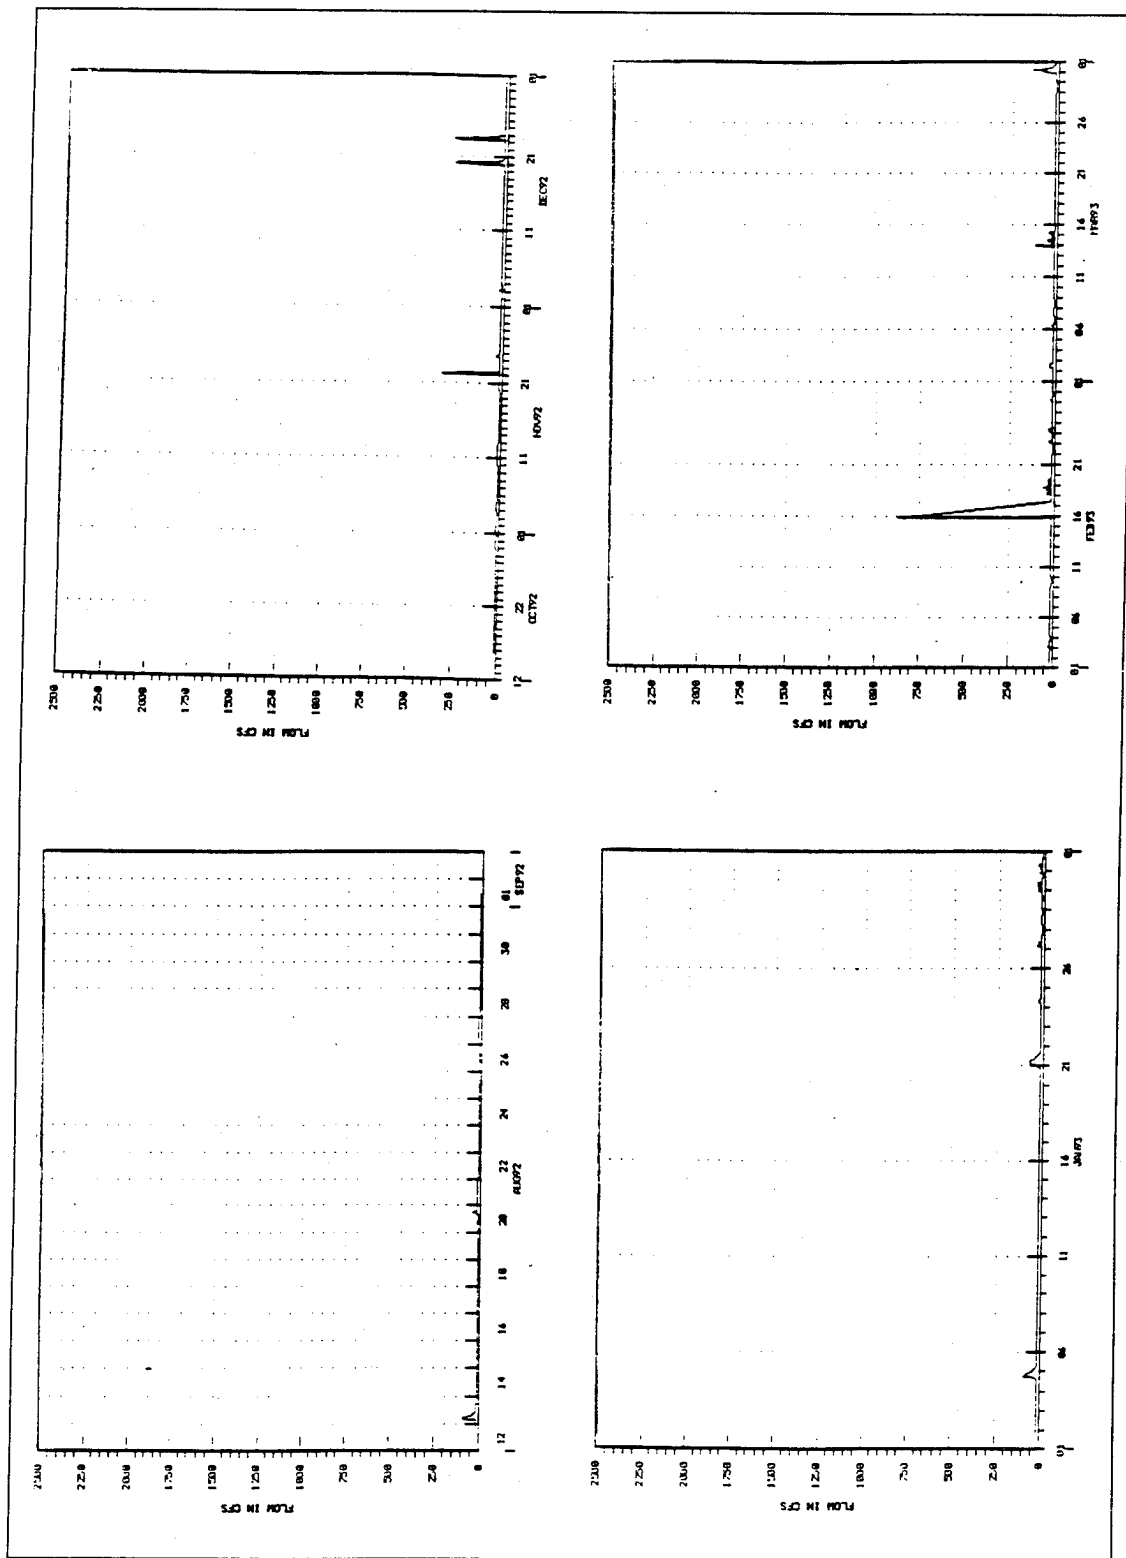
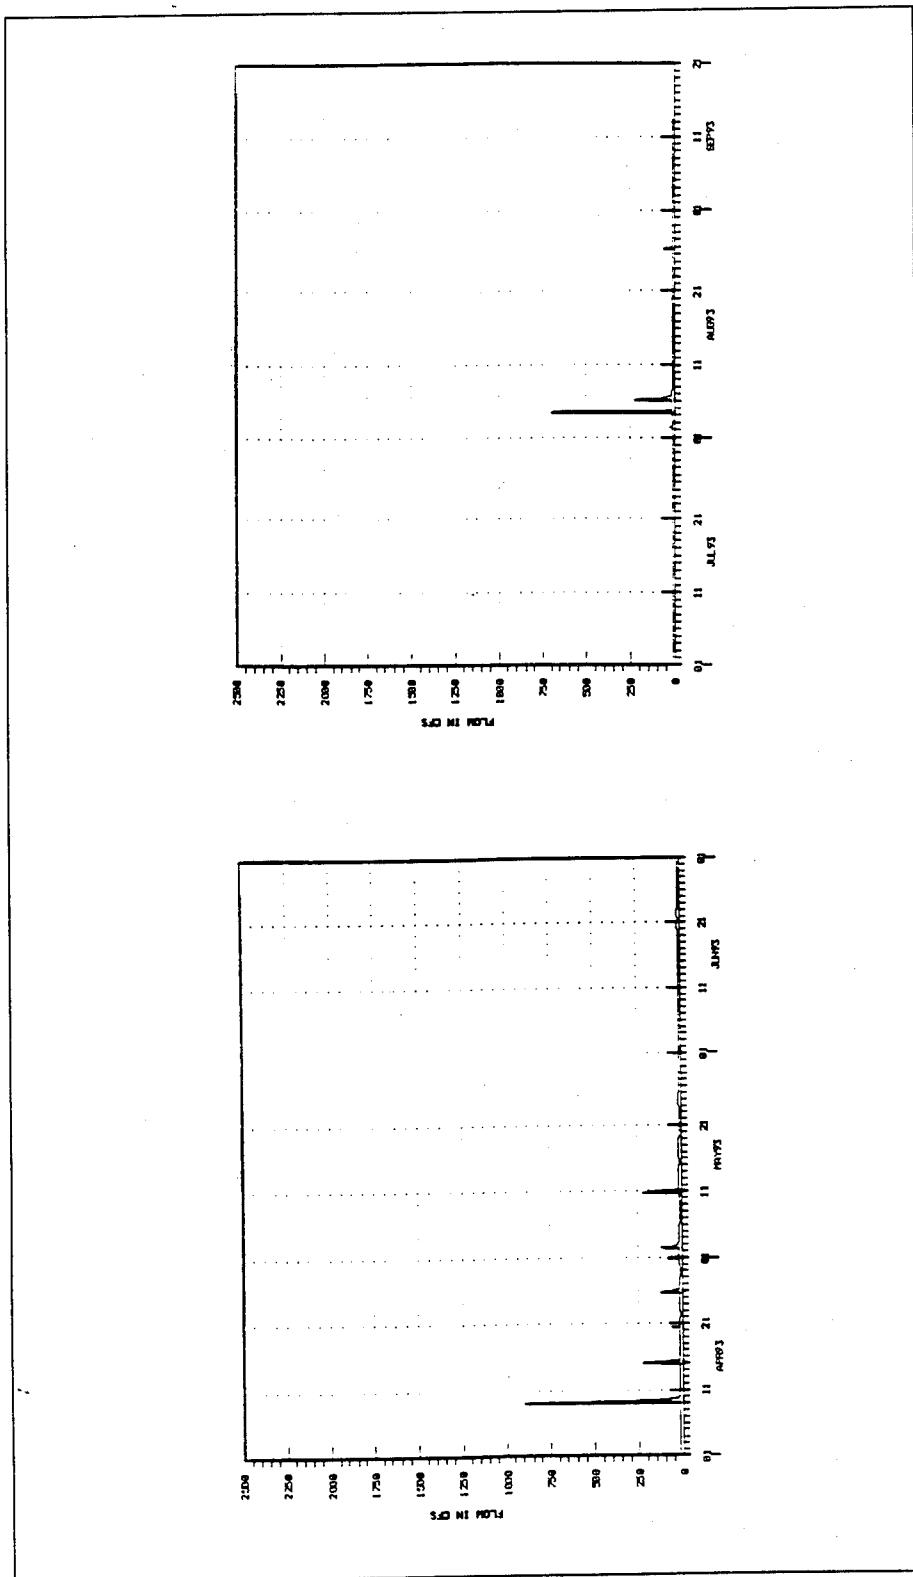
Using these discharge coefficients with the geometry of the cross section at the upstream and downstream gauge locations, a stage-discharge curve was developed for the head-and tailwater cross sections. Linear regression was applied to the stage-discharge curves to develop equations that were used to translate the stage hydrographs recorded at the site to discharge hydrographs (Figures 117-119).

Figure 117. Discharge hydrograph, Long Creek (October 1991-June 1992)

Figure 118. Discharge hydrograph, Long Creek (August 1992-March 1993)

Figure 119. Discharge hydrograph, Long Creek (April 1993-September 1993)

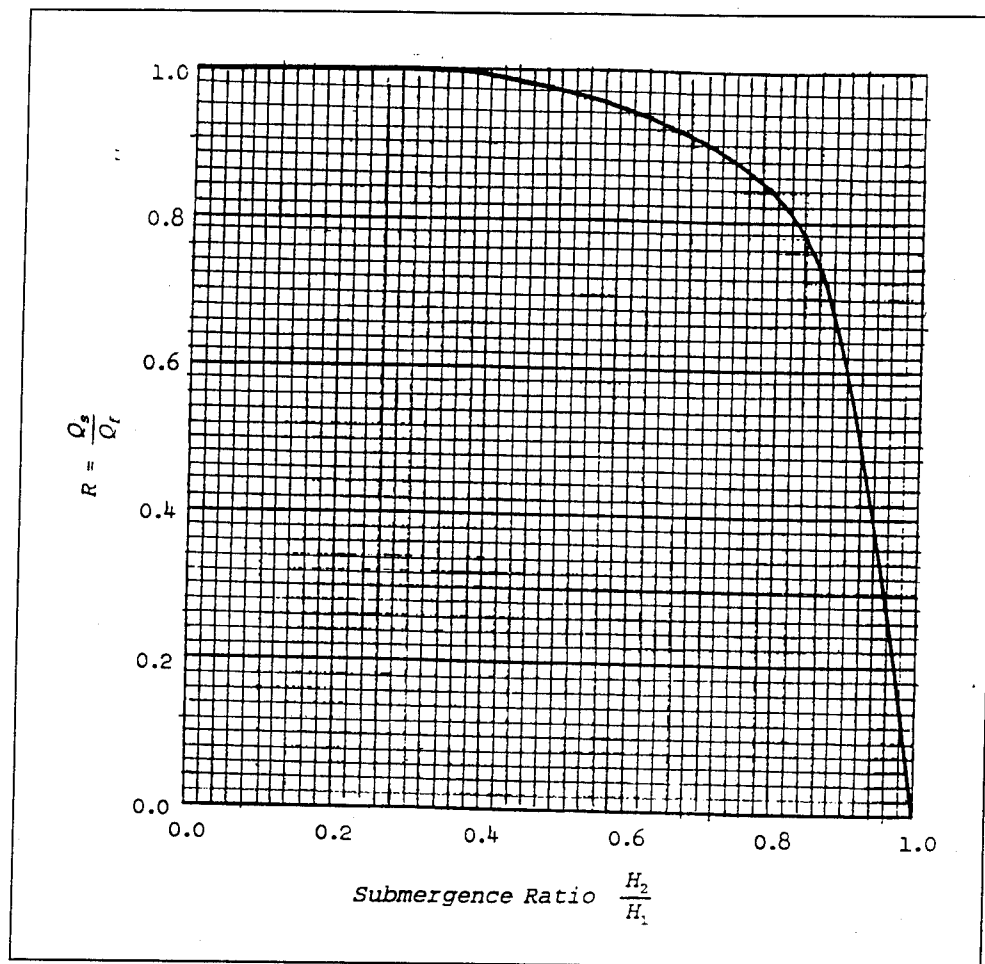
Figure 120. Hotophia Creek high-drop, effects of submergence

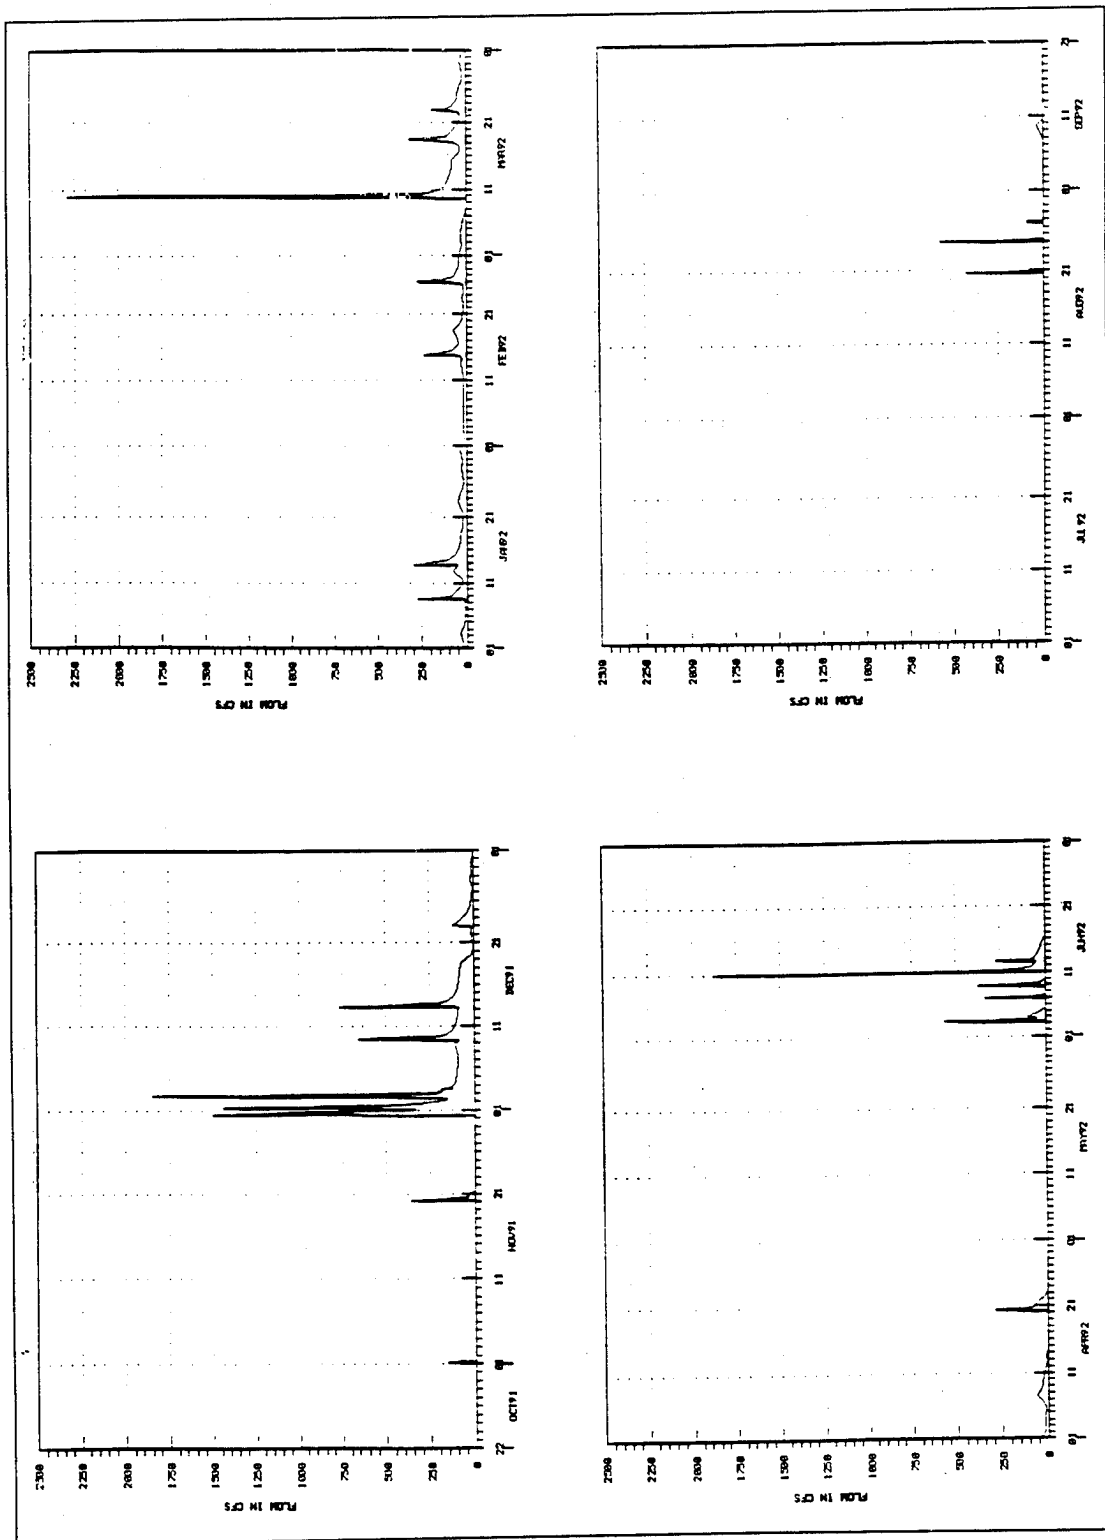
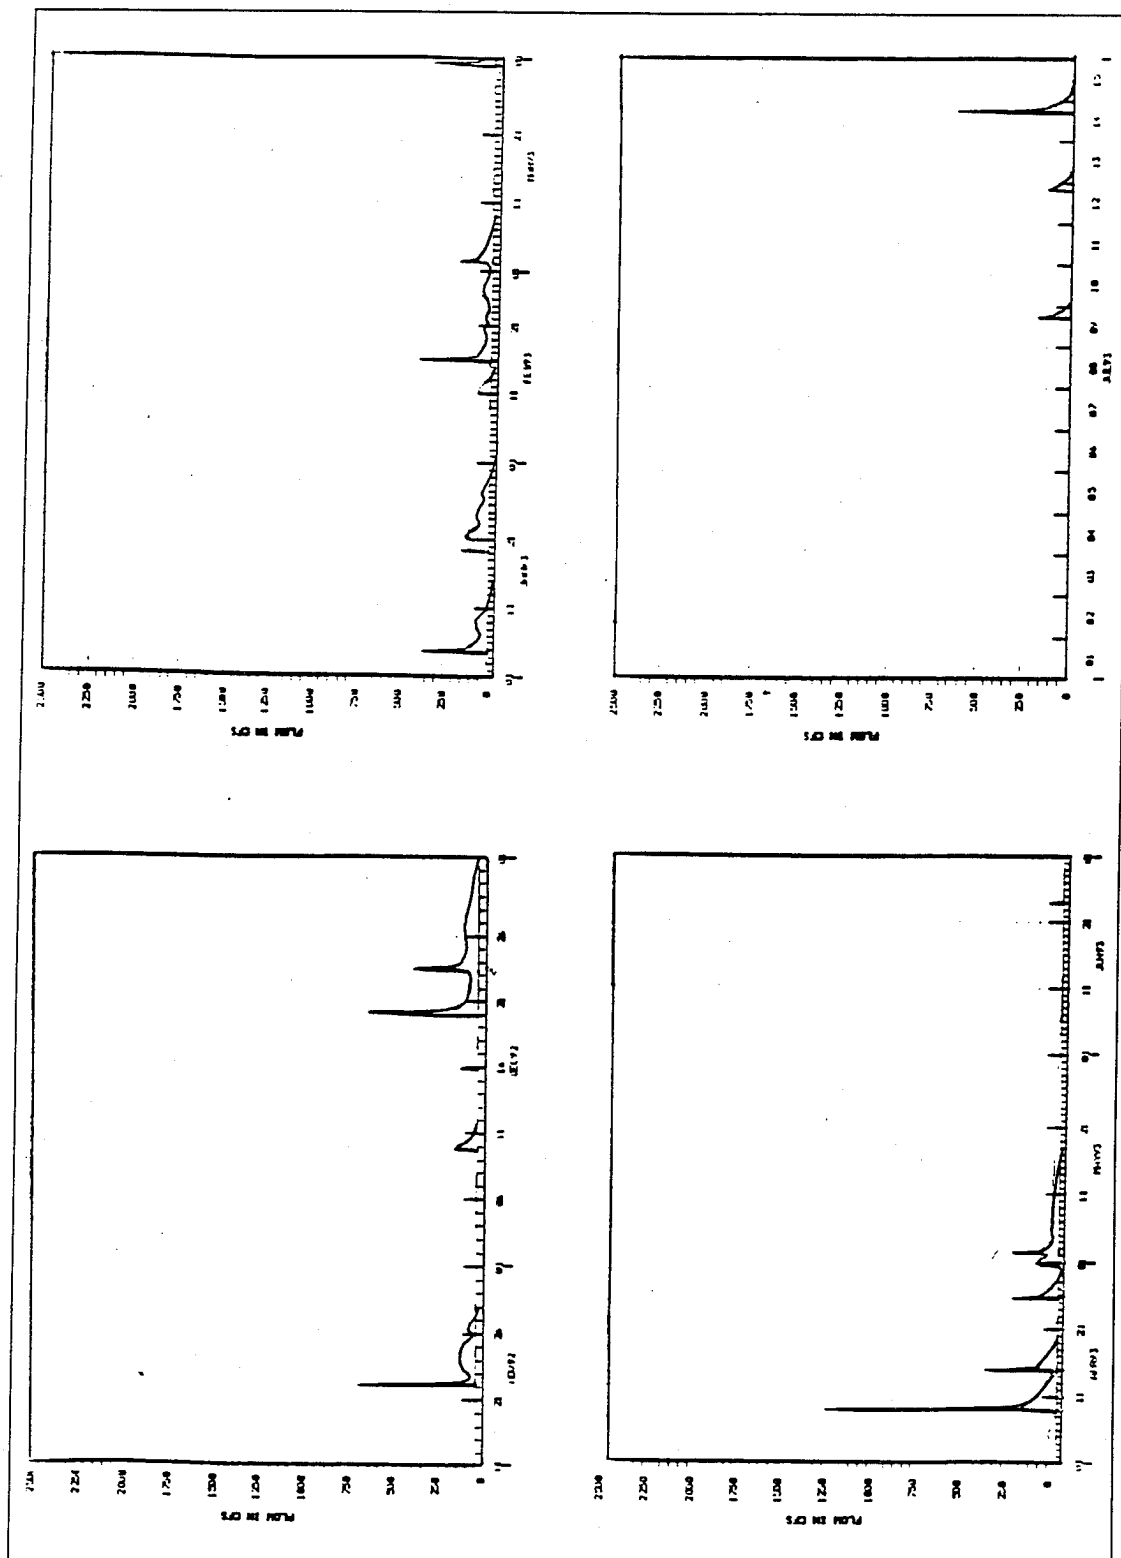
In a manner similar to that for the Long Creek low-drop structure, relationships were developed that were used to translate the stage hydrographs recorded at the site to discharge hydrographs (Figures 121 and 122).

Figure 121. Discharge hydrographs, Hotophia Creek (October 1991-September 1992)

Figure 122. Discharge hydrographs, Hotophia Creek (November 1992-July 1993)

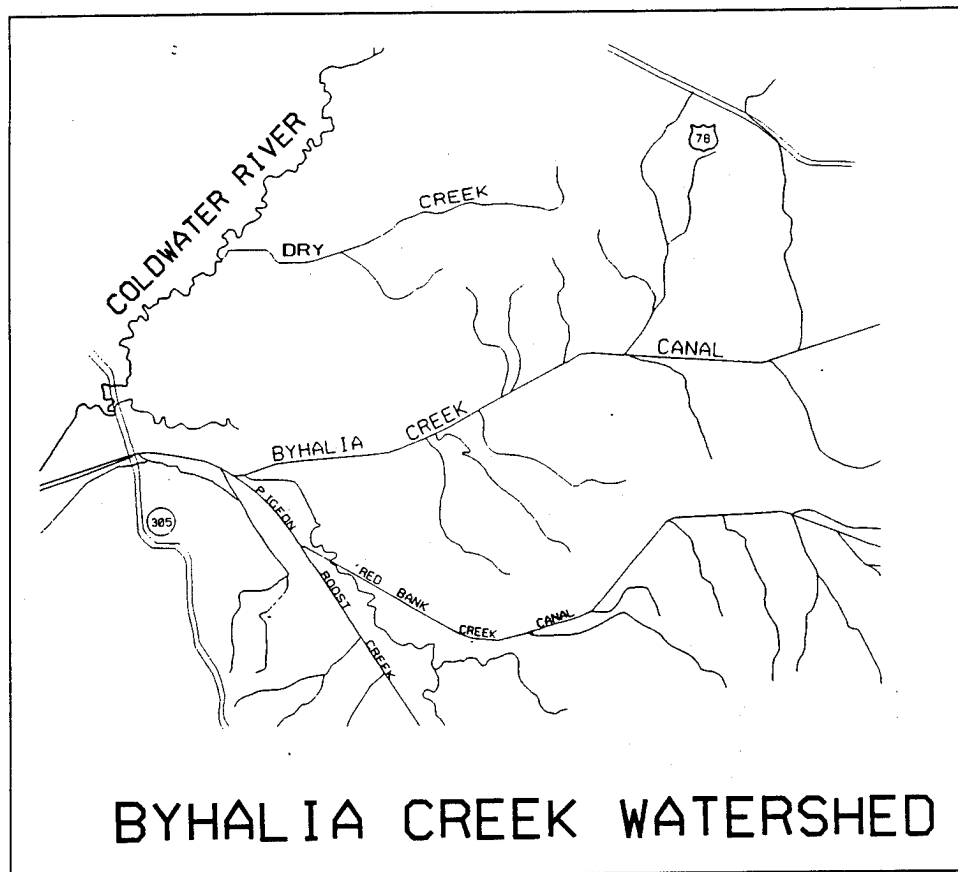
- a. A drainage basin map and network of stream channels was developed as shown in Figure 123.

Figure 123. Drainage basin map with network of stream channels

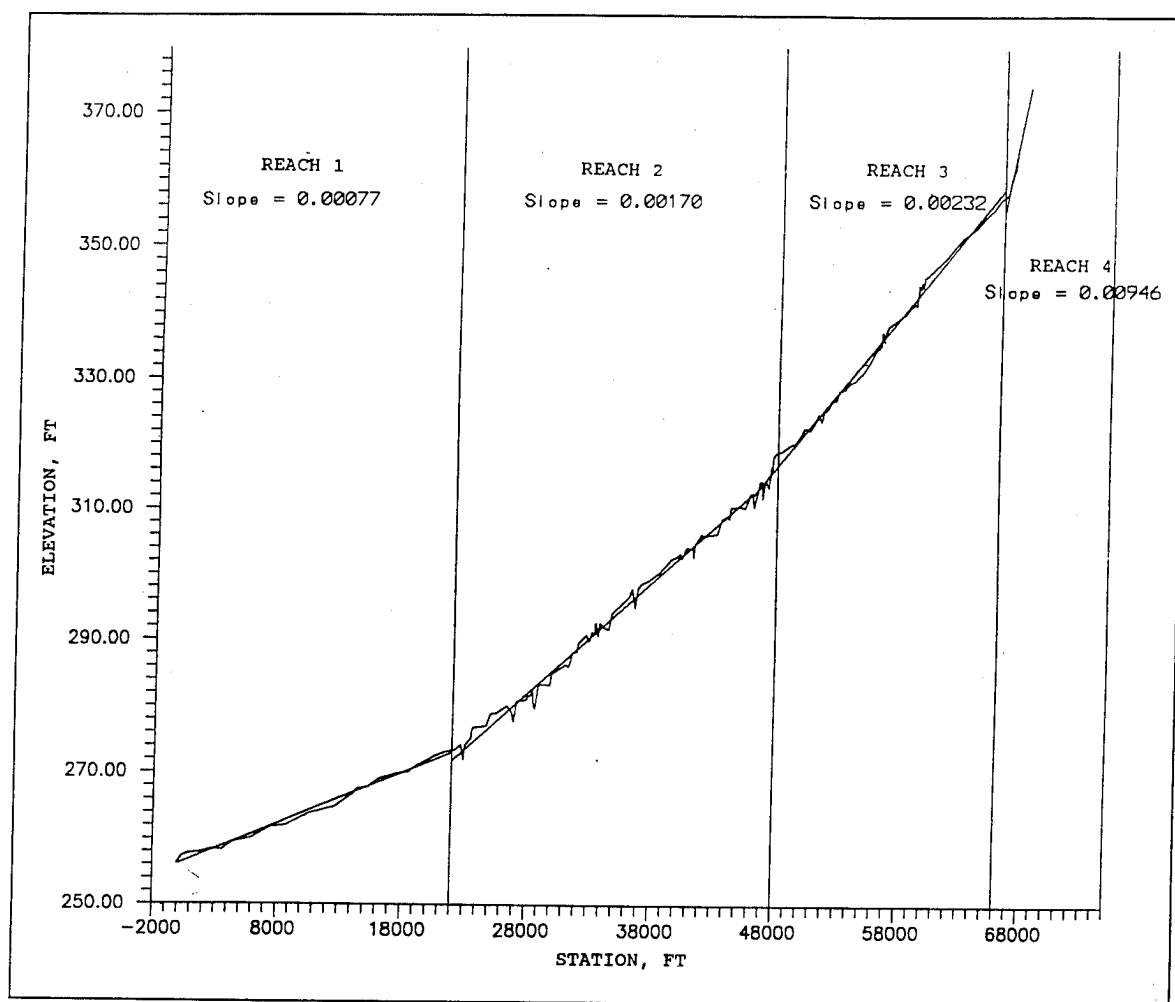
- b. The thalweg profile (elevation versus station) was plotted, and a thalweg slope was calculated for each natural break in that gradient. That process identified four reaches (Figure 124).
- c. Design channel cross section type B (Figure 45, page 81, of the Fiscal Year 1992 Report) was selected for this creek.
- d. HEC-2 was run for existing conditions using the 2-year flood for the channel-forming discharge.
- e. A reference reach was selected using output from the HEC-2 run and information from a site inspection of Byhalia Creek.
- f. A representative section in the reference reach was chosen and normal depth calculations were run with SAM to get composite width, depth, and velocity values.

Figure 124. Average thalweg slopes by reach

The thalweg profile data from the Byhalia Creek survey were read into Grapher and the profile shown in Figure 124 was plotted. Breaks in the natural gradient are obvious. These data were fitted with four straight-line segments, and reach limits were set at each break point.

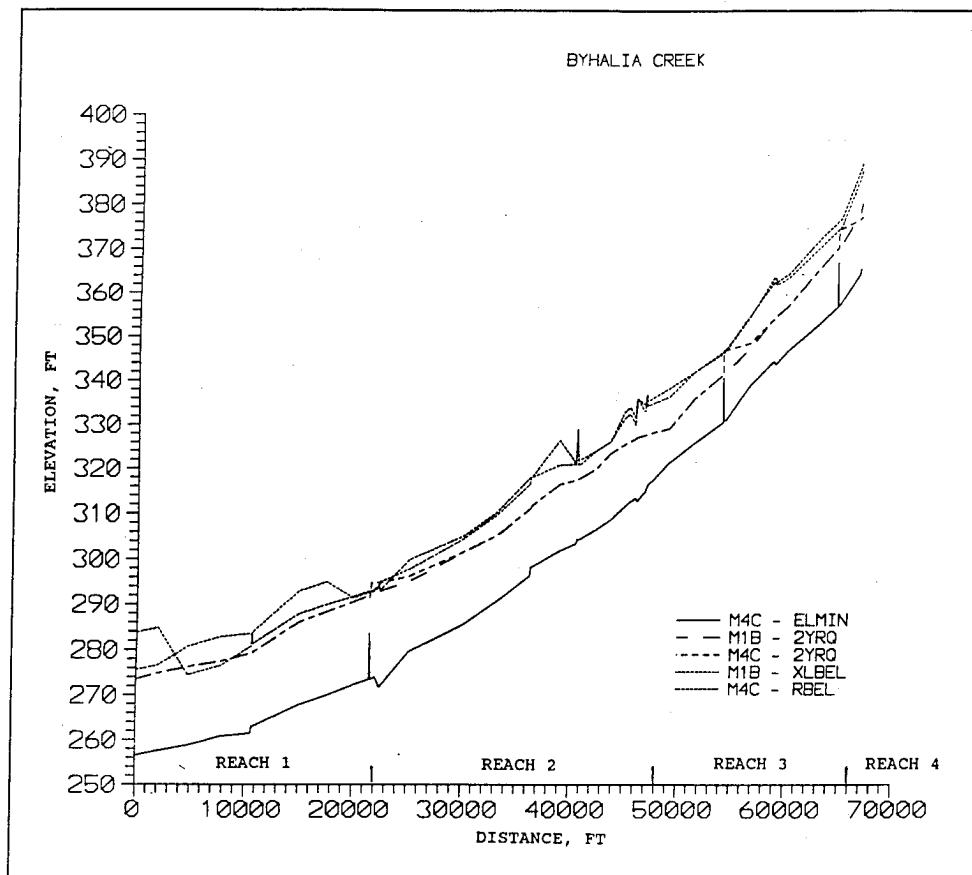
HEC-2 was run in the existing geometric model, and plots of the water surface profile, bed elevation, and bank heights were made with Grapher (Figure 125). Some data manipulation is necessary to bring the data files into Grapher, but the procedure is manageable. Moreover, there may be other graphical packages that can be used more directly. Grapher is mentioned because this analysis was done using that software package.

Figure 125. Water surface profile, bed and bank elevation plots

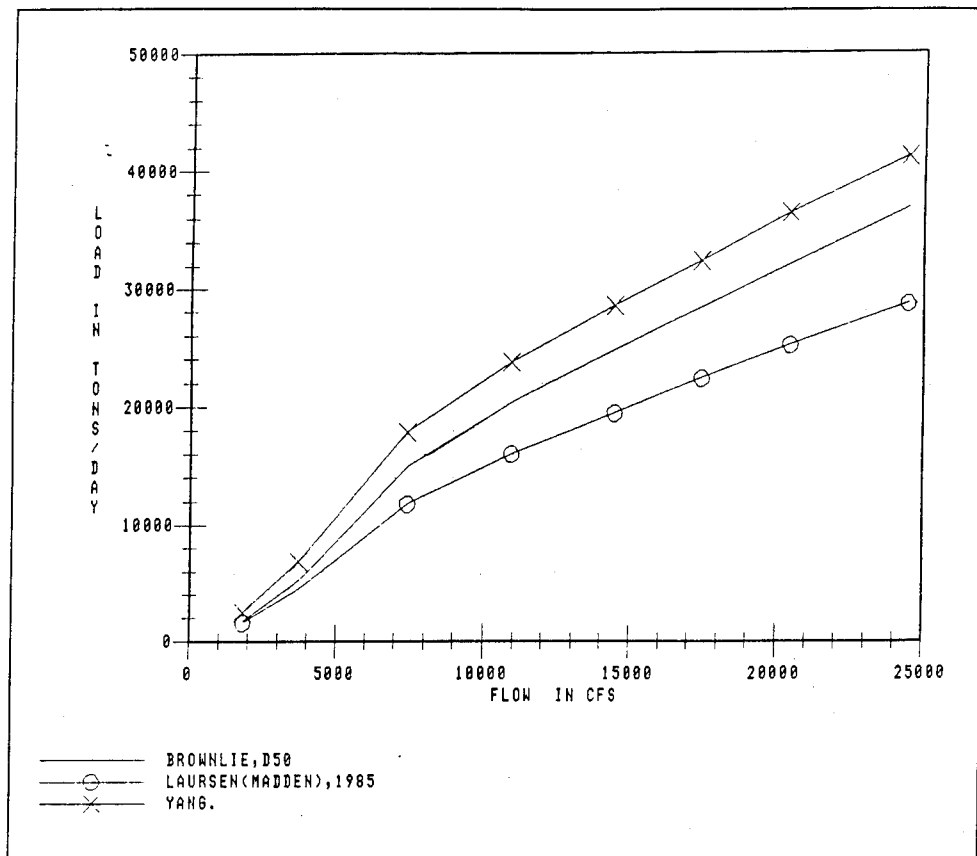
SAM.aid predicted Yang, Yang D_{50} , and Laursen-Madden. None of these are available in the stable channel analytical method. That method is presently built around the Brownlie D_{50} sediment transport function. Therefore, both the Yang and the Brownlie functions were made active. Results are shown in Figure 126. These results are sufficiently close together to adopt Brownlie for the calculations.

Figure 126. Transport function results

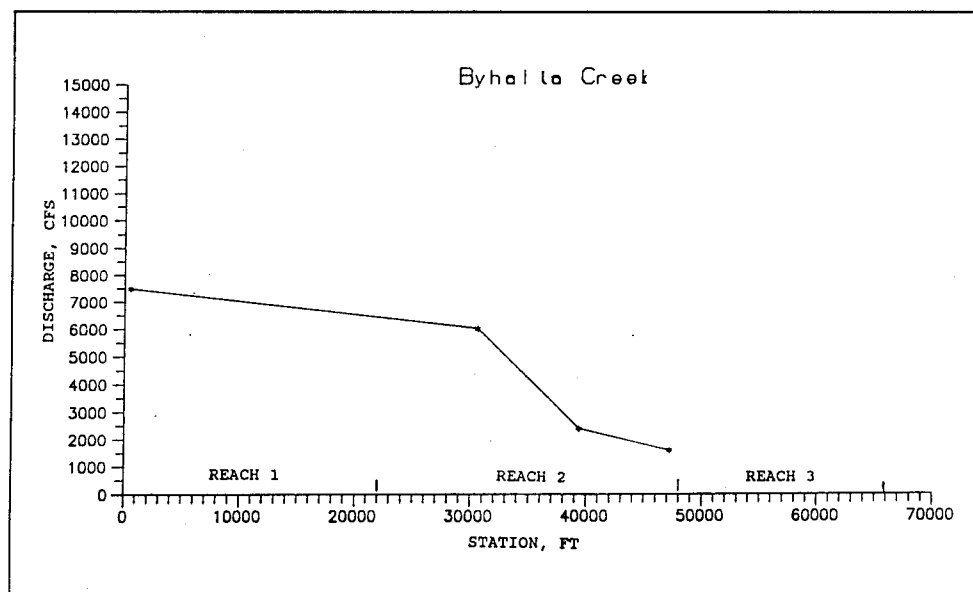
The next task was to establish the hydrologic parameters for the design. The 2-year discharge of the reference reach, 7,500 cfs, was decreased as the drainage area decreased in reaches 2, 3, and 4. These values, shown in Figure 127, were furnished by Vicksburg District. Locations are identified by channel station.

Figure 127. The 2-year discharge along Byhalia Creek
